Re: Request for Information Pursuant to Section 308 of the Clean Water Act
Canal Asphalt, Inc. 800 Canal Street, Mount Vernon, NY 10550
Docket No. CWA-IR-16-008

COMPLIANCE EVALUATION INSPECTION REPORT

Compliance Evaluation Inspection: Canal Asphalt, Inc., New York 10550	
Inspection Date: October 22, 2015	Inspection Time: 10:30AM-11:15AM
EPA Inspectors: Cyndy S. Kopitsky, Physical Scientist and Marissa N. Abbruscato, Physical Scientist USEPA Region 2, DECA, Water Compliance Branch, (212) 637-3832 and (212) 637-4293 respectively	
NYSDEC Representative: Eric Kim (914) 428-2505 x-351	
Facility Representative: Maria Satiro-Seguinot, Manager (contact provided to EPA)	
Site Information: CANAL ASPHALT, Inc. 800 Canal Street Mount Vernon, NY 10550 SIC Code: 2951

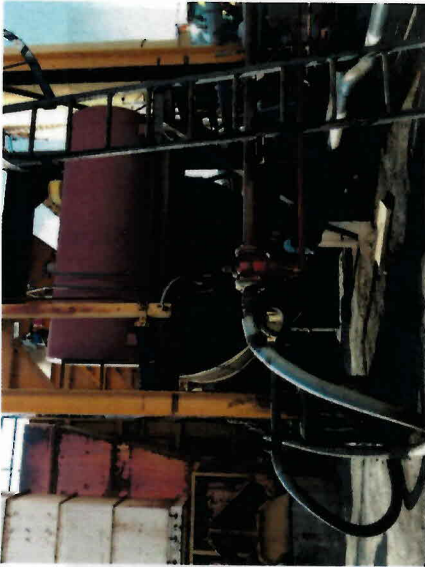
Hutchinson Recon I Phone 10-2015 484

4. EPA Inspector Kopitsky observed a propane tank, containers or drums, and operation machinery with signs of grease or oil in the general area and exposed to stormwater (Photos iPhone 10-2015 484, 516, 486, and PA210013).

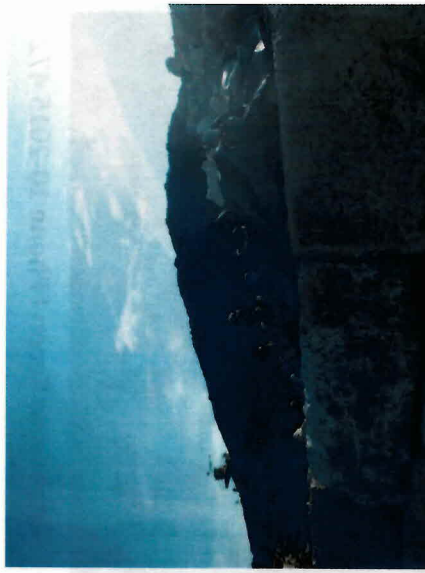
PA210003

At the time of the inspection EPA inspector Kopitsky observed three (3) asphalt stock piles. The piles were located at the entrance along Canal Street and along the back side of the Facility along Eastchester Creek (Photos PA210003, I Phone 10-2015 497, 505, & 513).

3. At the time of the CEI, three (3) asphalt/stock piles were stored directly adjacent to Waters of the US, uncovered, and exposed to stormwater. Wherever practicable, exposed materials should be stored under a roofed structure or under a tarp (Photos PA210003, PA210009, iPhone 10-2015 497, and 517).

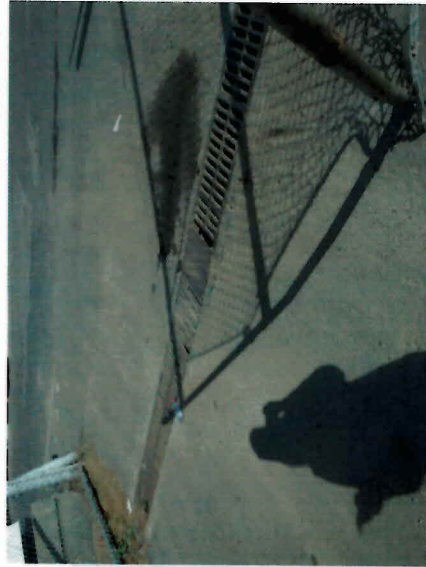
PA210005

There are two (2) observed storm drains at the facility. One drain was located at the facility entrance, another drain was covered and marked with an orange cylinder (Photo PA210005, I Phone 10-2015 498). A storm sewer was located close to the entrance and was not opened at the time of the inspection (Photo I Phone 10-2015 478)

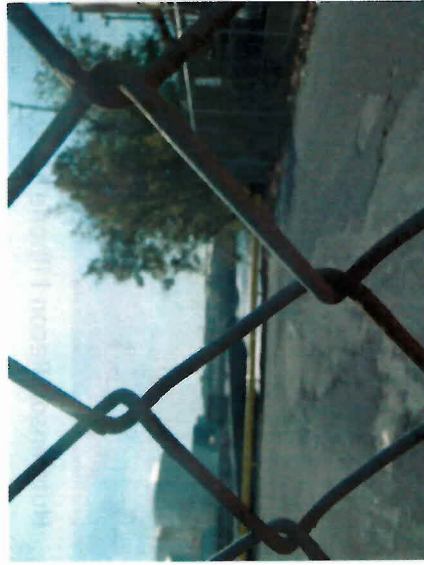
PA210014

The Facility is bordered by Canal Street and Eastchester Creek. At the time of the inspection, EPA observed a metal fence along one edge of the facility, separating the neighboring facility. There was an outfall pipe located between the two locations (Photo PA210014, iPhone 10-2015 489)

1. At the time of the inspection, EPA Inspector Kopitsky observed an outfall pipe located adjacent to the Canal facility that had dry weather flow directly into the channel (described above) which feeds to Eastchester Creek which flows into the Hutchinson River.

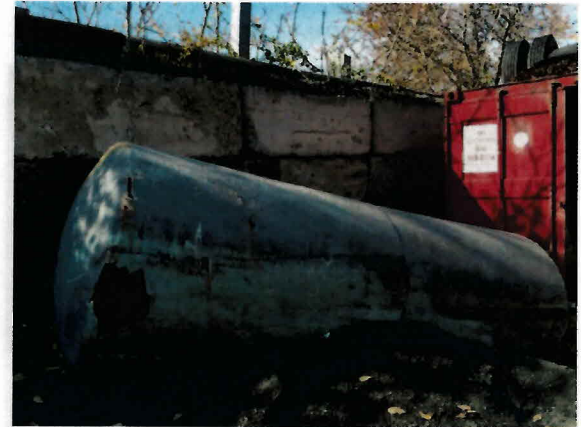
Hutchinson Recon I Phone 10-2015 502

At the time of the inspection, there was a fuel tank laying on its side in a portion of the asphalt and an inactive plow vehicle used for operations (Photo I Phone 10-2015 502).

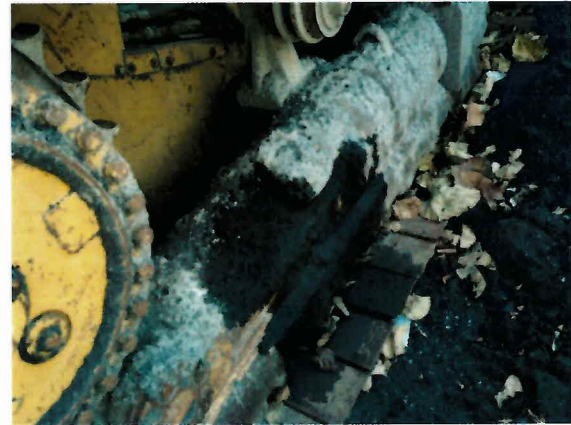
Hutchinson Recon I Phone 10-2015 512

500	Stock pile of asphalt
501	Asphalt storage area
502	Inactive fuel drum
503	Storage
504	Asphalt area around inactive truck
505	Asphalt storage
506	Asphalt storage
507	Asphalt storage
508	Runoff area
509	Runoff area

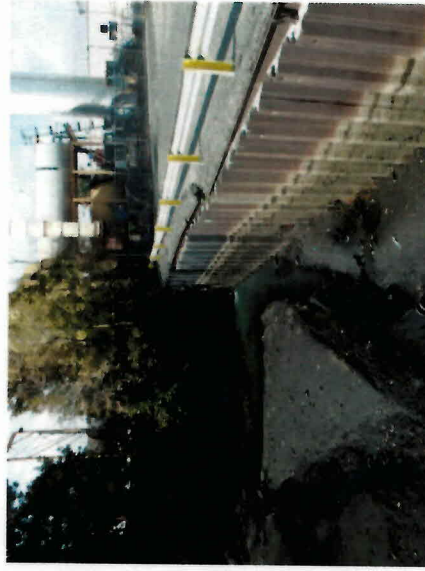
PA220025

The two (2) facilities are separated by a small unnamed channel along Eastchester Creek. At the time of the inspection there were approximately twenty (20) dead fish and the water was very dark in color with an oily sheen. The tide was low at the time of the inspection (Photos PA220025, PA220026, PA220027, and PA220031)

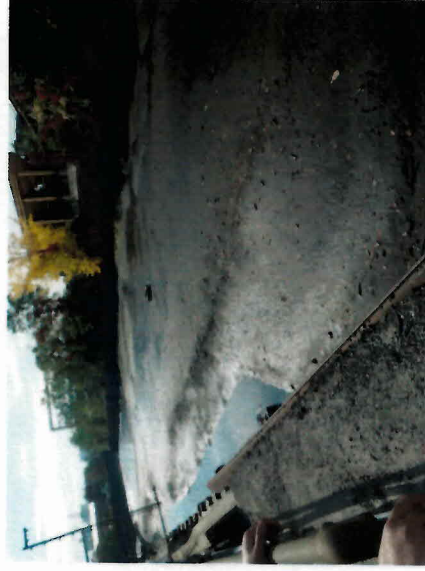
510	Runoff area
511	Runoff area
512	Oily discharge from equipment
513	Storage area
514	Boarding the Creek
515	Storage of asphalt
516	Storage of asphalt
517	Storage of asphalt
518	Side view of facility
PA210001.jpg	Facility entrance
PA210002.jpg	Facility entrance
PA210003.jpg	Material storage
PA210004.jpg	Truck entrance
PA210005.jpg	Drain at entrance
PA210006.jpg	Storage area
PA210007.jpg	Photo in error
PA210008.jpg	Photo in error
PA210009.jpg	Street view/stock piles
PA210010.jpg	Stock piles
PA210011.jpg	Street view
PA210012.jpg	Street view
PA210013.jpg	Dry absorb around truck area
PA210014.jpg	Dry absorb around truck area
PA210015.jpg	Street view
PA220025	Outfall-Dry weather flow
PA220026	Low tide-Dead fish and oily black soil conditions
PA220027	Same as above
PA220031	Same as above
